# Analysis of defects on machined surfaces of aluminum alloy (Al 7075) using imaging and topographical techniques

**Abstract.** Aluminum alloys 7075 (Al 7075) are widely used for various industrial components in which machining operations are often conducted during their manufacturing process. However, the machining operations could introduce defects on the machined surfaces of the components which will be carried over and may lead to either issues in the subsequent fabrication process or failure during the products' service life. This study investigates the machined surface's defects of Al 7075 underwent drilling operations using imaging and topographical techniques which include optical microscope, scanning electron microscope and 3D surface profiler. Surface roughness was analysed with respect to the surface defects to investigate the correlation between the roughness parameters and topographical features of the machined surfaces. The defects found on the machined surfaces of Al 7075 are microcrack, adhesion, feed mark and burr. Surface roughness was found to be highly influenced by topographical features particularly feed mark. Thus, in addition to measuring the roughness, ins

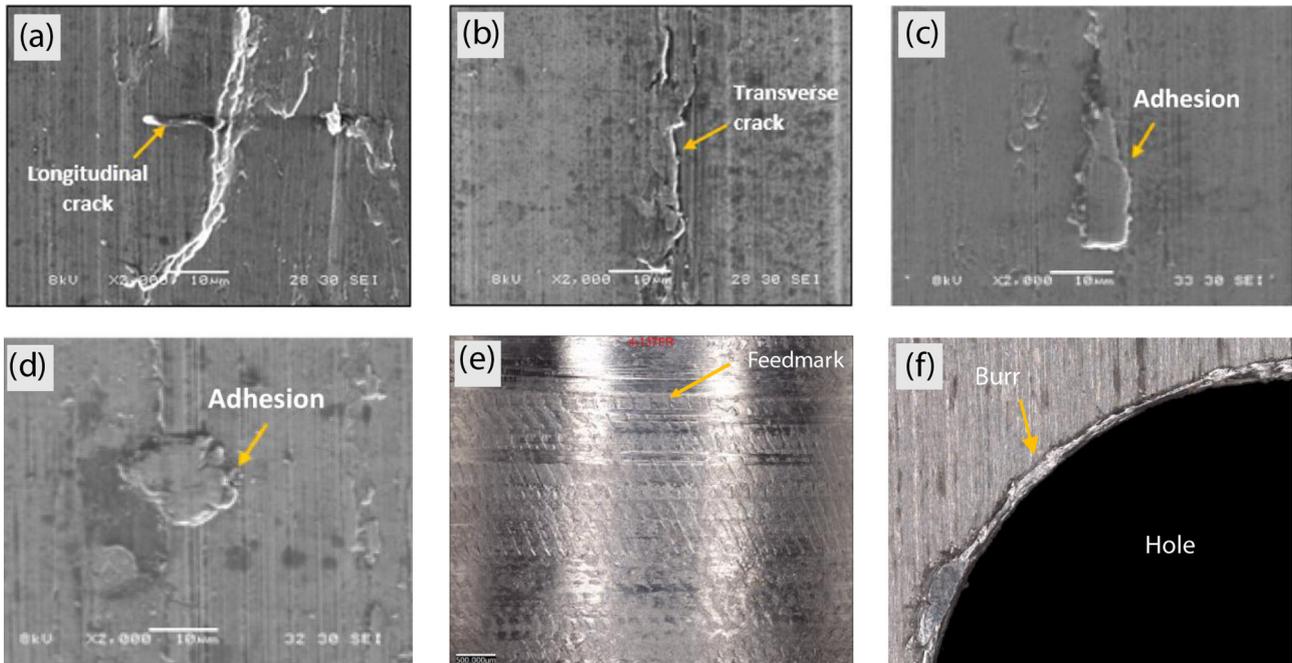
topographical techniques. The defects discovered on the machined surfaces of Al 7075 are (a) longitudinal crack, (b) transverse crack, (c, d) adhesion or overlapping, (e) feed mark, and (f) burr as shown in Figure 2. The longitudinal and transverse cracks observed on the machined surface using Scanning Electron Microscope (SEM) at the 2000 $\times$  magnification rate were found to have the length and width within 0.5–120  $\mu\text{m}$ . This microcrack was not observed during the examination using optical microscope which indicates the need of using a higher magnification microscopy for better evaluation of the surface features. Both types of microcracks (longitudinal and transverse) which were observed using the SEM occurred mostly on the surfaces produced by drilling at the lower cutting speed of 120 m/min regardless of feed rates and drilling environment. The crack on the machined surface is likely to occur as a result of stress concentration zones formed on the surfaces due to tool-chip friction during drilling process. In addition, microcracks were formed as residual stress reaches the fatigue strength of Al 7075.

Furthermore, material adhesion with various size and pattern on the machined surfaces of Al 7075 were also observed using SEM as shown in Figures 2c, 2d and surface profiler as shown in Figure 3. On average, the height of material adhesion on the surfaces were found to be approximately between 10  $\mu\text{m}$  and 15  $\mu\text{m}$ . Adhesion on the machined surfaces is the result of chip formation and material softening during drilling process and they are likely to occur when drilling was conducted in dry condition and at higher cutting speeds due to higher heat generation. The examination of material adhesion was harder using optical microscope due to limited height profile. Generating the surface topography using 3D surface profiler provided detailed height profile which can be seen in Figure 3. The depth and height profile of the adhesion are shown through a colour difference which facilitates the detection and provide comprehensive insight of the defects compared to optical microscopy and SEM.

Feed mark is another type of defects that were observed on the machined surfaces of Al 7075, as shown in Figure 2e. Feed mark is considered as common defects due to machining process. Feed mark can be distinguished on the machined surface as the cutting path profile that was resulted due to material removal process. The severity of the defects can be controlled by adjusting the feed rate of the machining process from which a higher feed rate resulted to deeper feed mark [7,8]. The occurrence of feed

**Fig. 2.** Types of defects observed on the drilled holes and machined surface of Al 7075 (a) longitudinal crack, (b) transverse crack, (c, d) adhesion, (e) feedmark, (f) burr.

mark was observed to be consistent on each drilled hole regardless of drilling parameters. Continuous pattern of cutting tool path can be observed on the surfaces through imaging techniques by optical microscope as shown in Figure 2e. The feed mark was commonly observed to occur parallel to the cutting feeds during drilling process. However, analysis through optical microscope does not provide information on the height and depth profiles of the feed mark on the surfaces. Therefore, the use of 3D profiler is needed to provide detailed information on the height profile. Figure 4 shows the topographical features of the feed mark observed on the surfaces, which were analyzed using the 3D surface profiler. The height and depth profile of the feed mark was observed to vary up to  $15\ \mu\text{m}$  which are highlighted by the color difference.

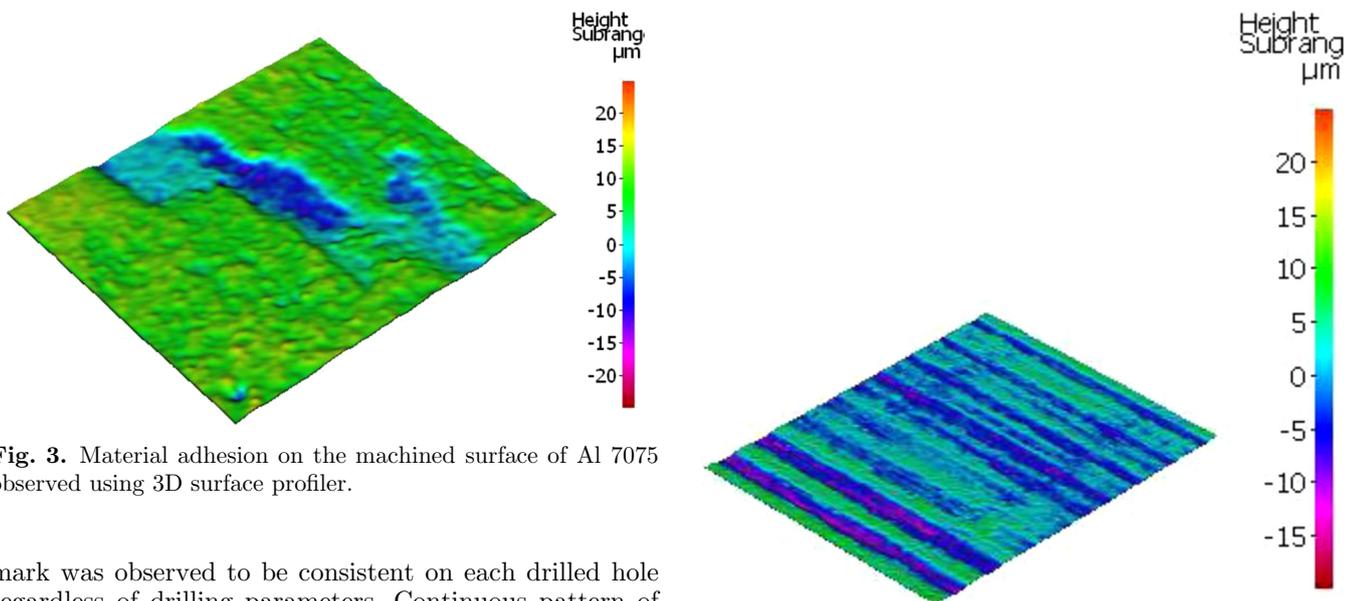
**Fig. 3.** Material adhesion on the machined surface of Al 7075 observed using 3D surface profiler.

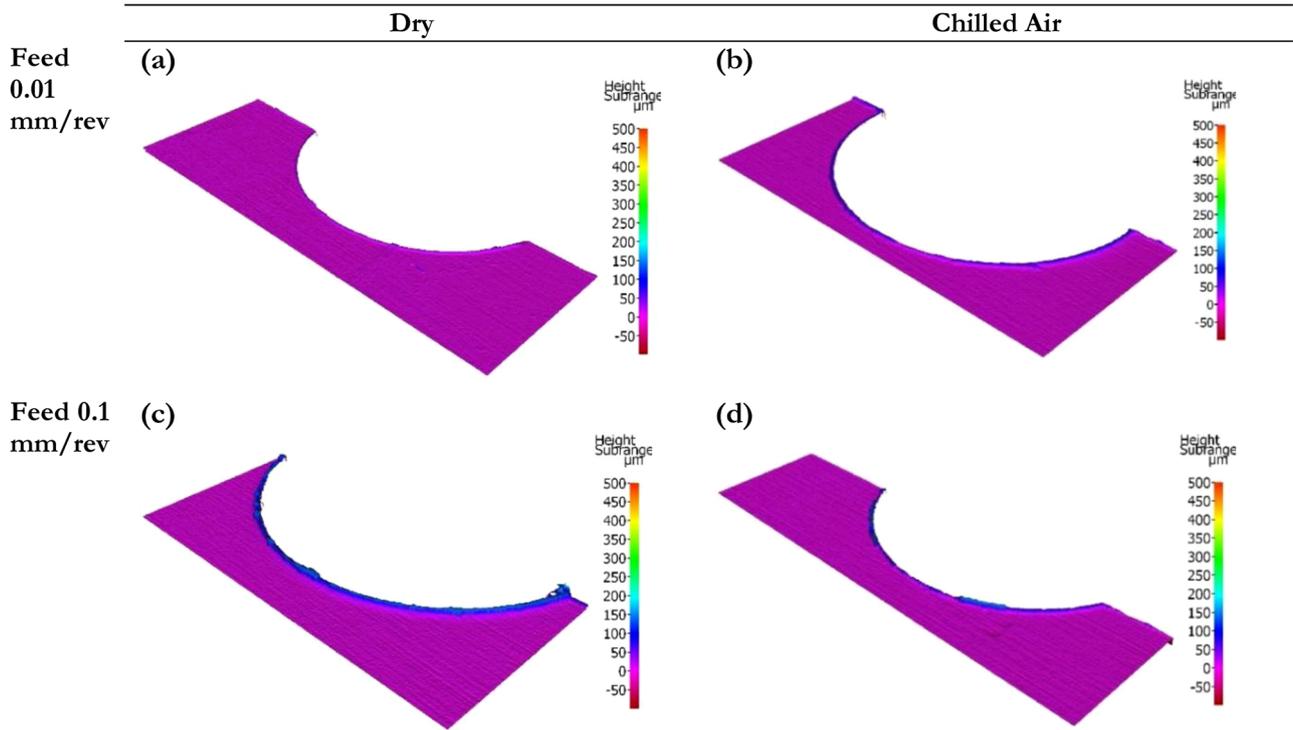
Burr existence which was observed at the hole exit using optical microscope are shown in Figure 1f. The burr occurs due to plastic flow of material during drilling process [9]. However, the images generated through imaging method utilizing the optical microscope does not provide information on the height of the burrs. The topography of burrs generated through topographical techniques utilizing 3D surface profiler are shown in Figures 5 and 6.

Fig. 5. Burr produced by drilling at lower cutting speed of 120 m/min, observed using 3D profiler.

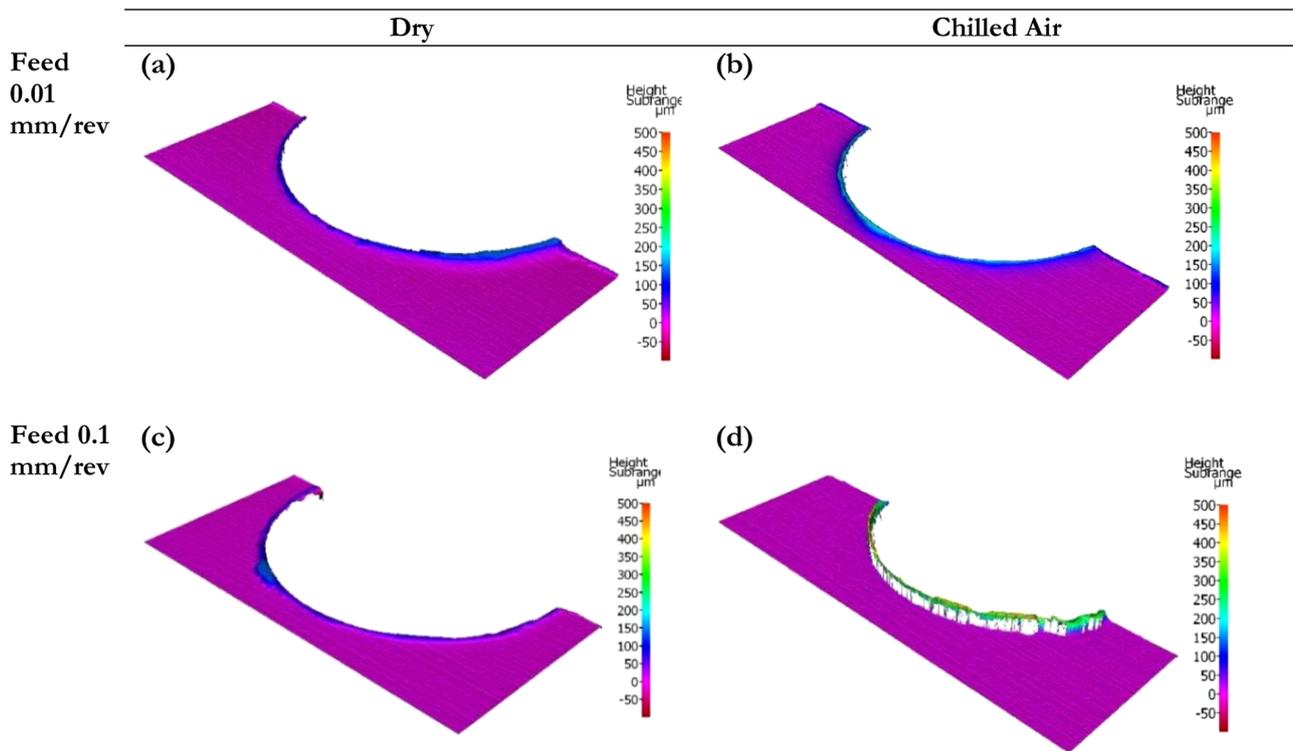
Fig. 6. Burr produced by drilling at higher cutting speed of 160 m/min, observed using 3D profiler.

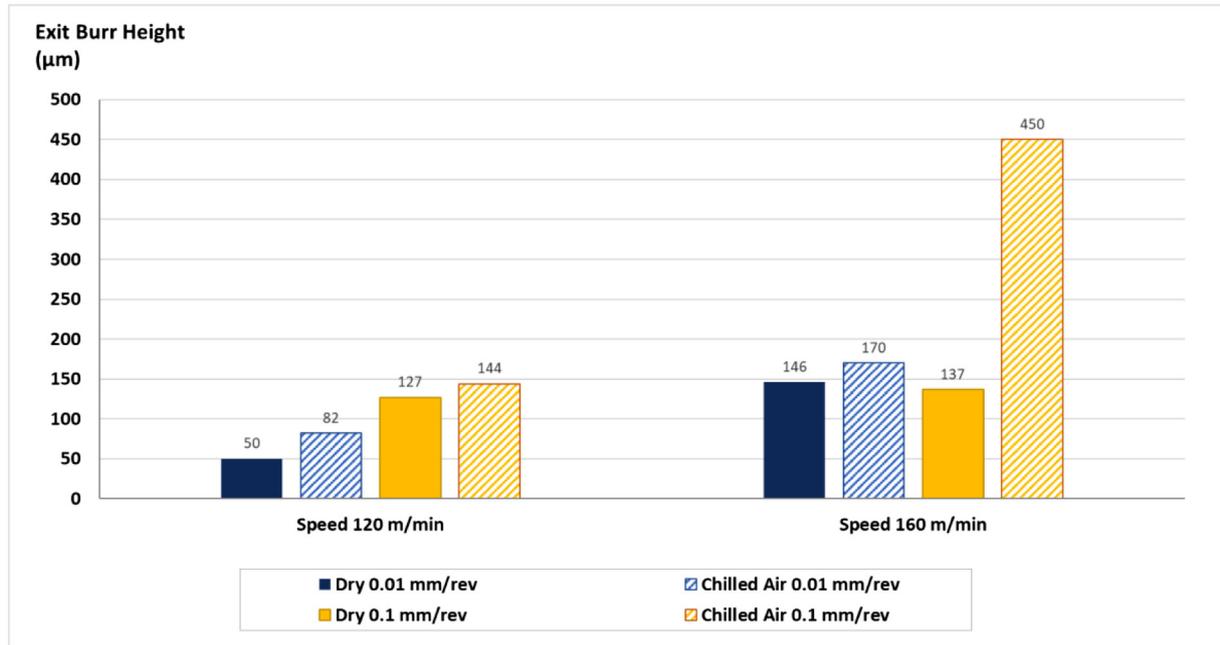
Fig. 7. Comparison of burr height measured using 3D profiler.

Through the topographic generated, the height profile of burr was generated and the comparison burr height produced by drilling at various cutting parameters is shown in Figure 7. The results indicate that cutting speed, feed rate and condition affect the burr formation in which higher cutting speed and higher feed rate resulted in the higher burr formation. The burr height difference up to 67.9% was observed between the holes produced by the cutting speed of 120 and 160 m/min. In addition, the height of burr was also observed to increase when the drilling processes was done in chilled air environment compared to dry environment. The higher burr observed on the Al 7075 samples drilled in chilled air is likely due to the reduction in cutting performance due to higher tool wear caused by material hardening [9].

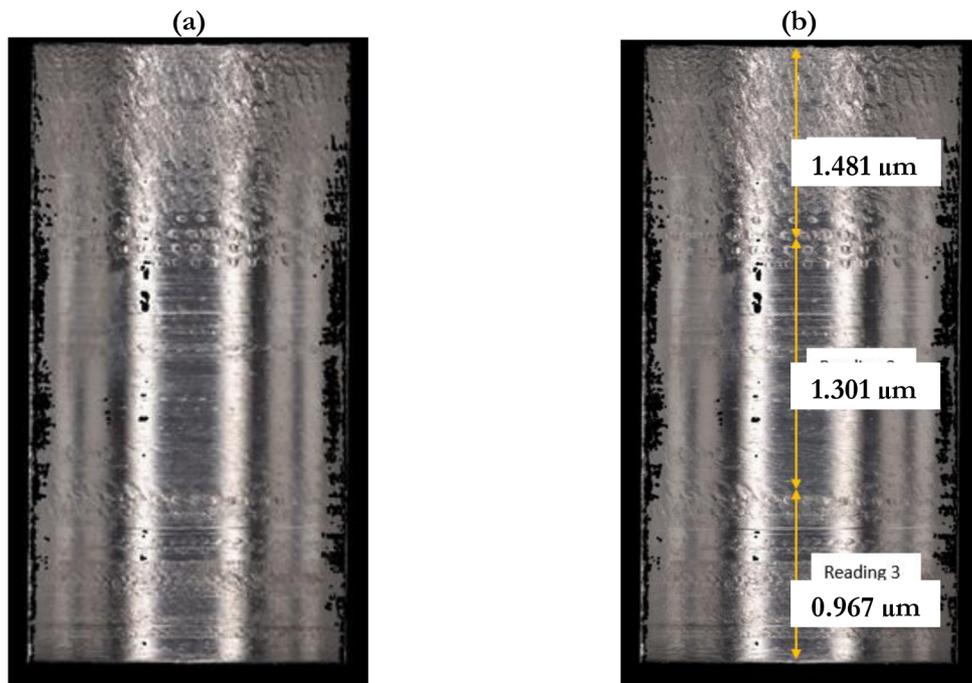
Fig. 9. Image of surface topography obtained through 3D surface profiler.

measurement resulted into more accurate reading compared to lower resolutions. Also, the 3D surface profiler permits measurement at various and more thorough location on the machined surfaces compared to the  $R_a$  measurement using stylus. For instance, Figure 9 shows the overall machined surface of Al 7075 obtained through 3D surface profiler. The result obtained shows the true condition of the surface which the topographic features

or feed mark observed are not consistent along the surface. Thus, correlation between surface roughness values and topographic features were made by measuring 3 different readings of  $R_a$  along the surfaces, as shown in Figure 9b. It is apparent that the  $R_a$  values measured for each location are significantly different. This was resulted due to inconsistent topographical features along the machined surfaces.
